Water Resources Management Report

4.0 SOLEBURY TOWNSHIP'S WATERSHEDS

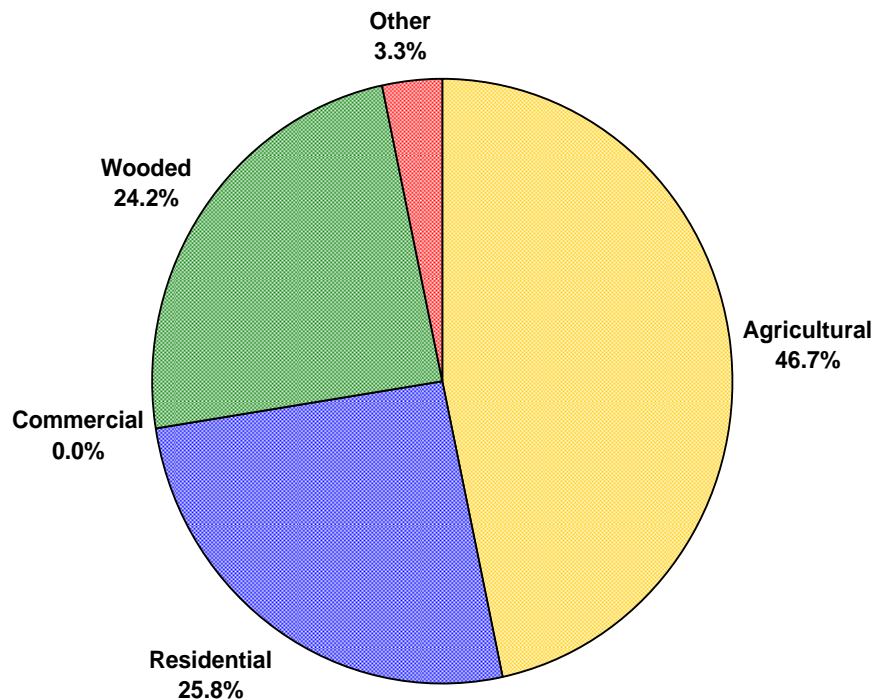
Figure 7. Land Use in Paunacussing Creek's Watershed (2000)

The predominant land use in Paunacussing Creek watershed is agricultural consisting of crops, open pastures/fields, and tree nurseries. Most of the agricultural areas are concentrated in the southern and eastern portions of the watershed. The non-agricultural areas primarily consist of residential areas/villages and forested areas (Figure 7).

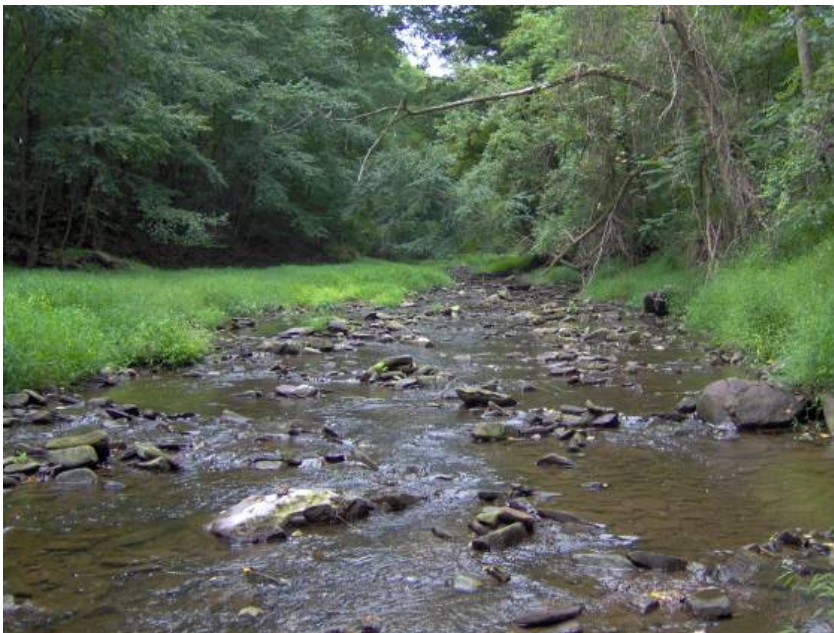
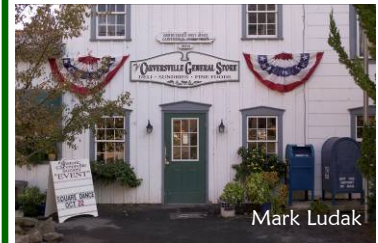
Paunacussing Creek's watershed is being impacted by streambank erosion and excessive siltation/sedimentation within the creek channel.

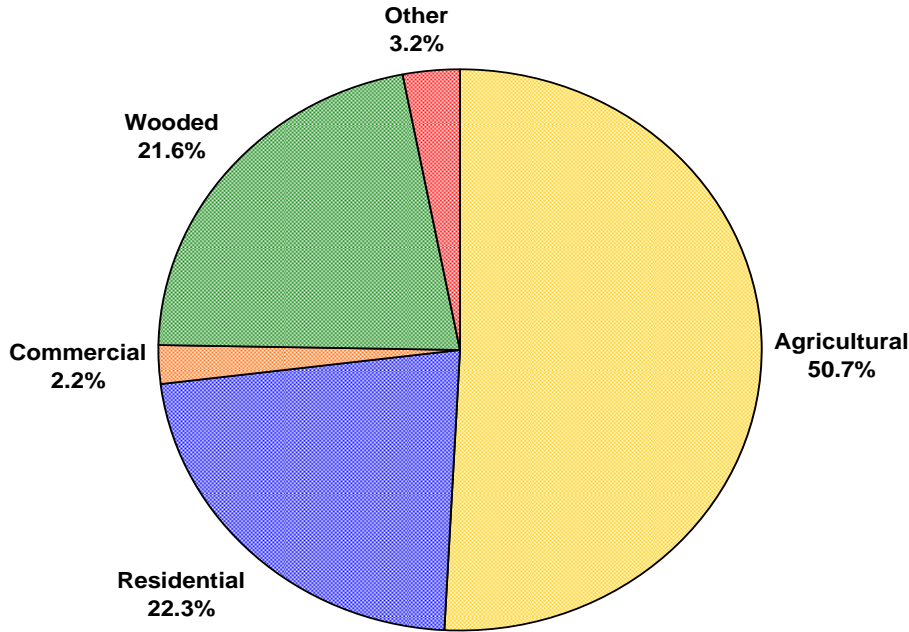
Figure 8. Land Use in Cuttaloosa Creek's Watershed (2000).

ment A). Agriculture is the primary land use in the watershed (50.7%) and commercial development is limited (Figure 8). Residential development which accounts for 22.3% of the area in the watershed consists primarily of historic residences on large property parcels, and the remainder of the watershed consists of forested land.

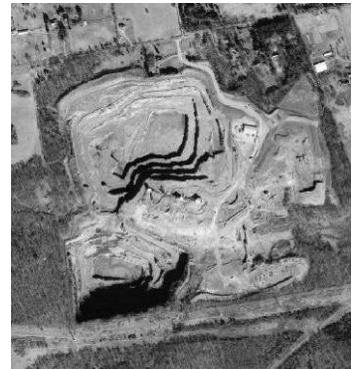
Aerial photograph of New Hope Crushed Stone quarry in 2000

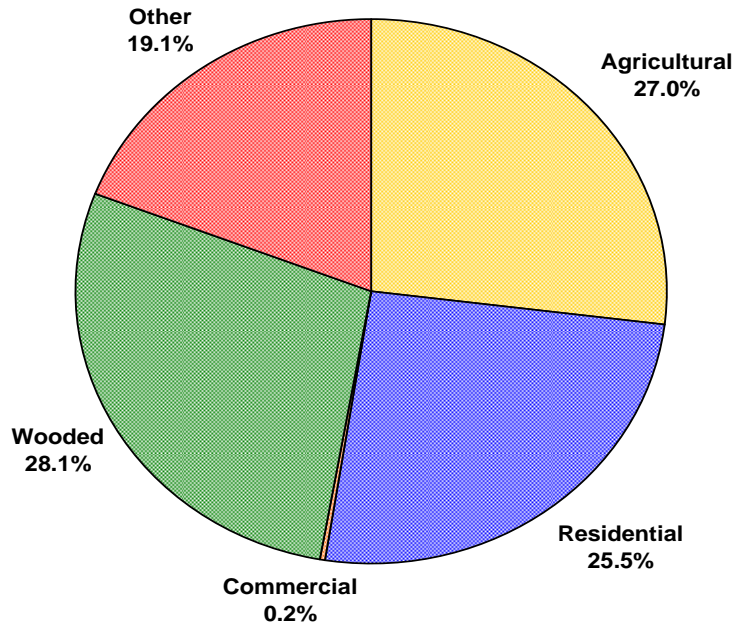
Figure 9. Land Use in Primrose Creek's Watershed (2000).

Wooded areas still account for a large percent of the watershed’s area (>25%) and primarily occur on the larger properties and along some of the stream reaches. Some of the more common tree species include American sycamore, black willow, American beech, black cherry, and walnut. Below the quarry, there is a large emergent
