**AUGUST 2002 GROUNDWATER ELEVATION AND
STREAM FLOW MONITORING
PRIMROSE AND AQUETONG CREEK DRAINAGE BASINS
SOLEBURY TOWNSHIP, PENNSYLVANIA**

**Solebury Township
3092 Sagan Road
Solebury, Pennsylvania 18963**

November 2002

**Vincent Uhl Associates, Inc.
P.O. Box 93
Washington Crossing, Pennsylvania 18977**

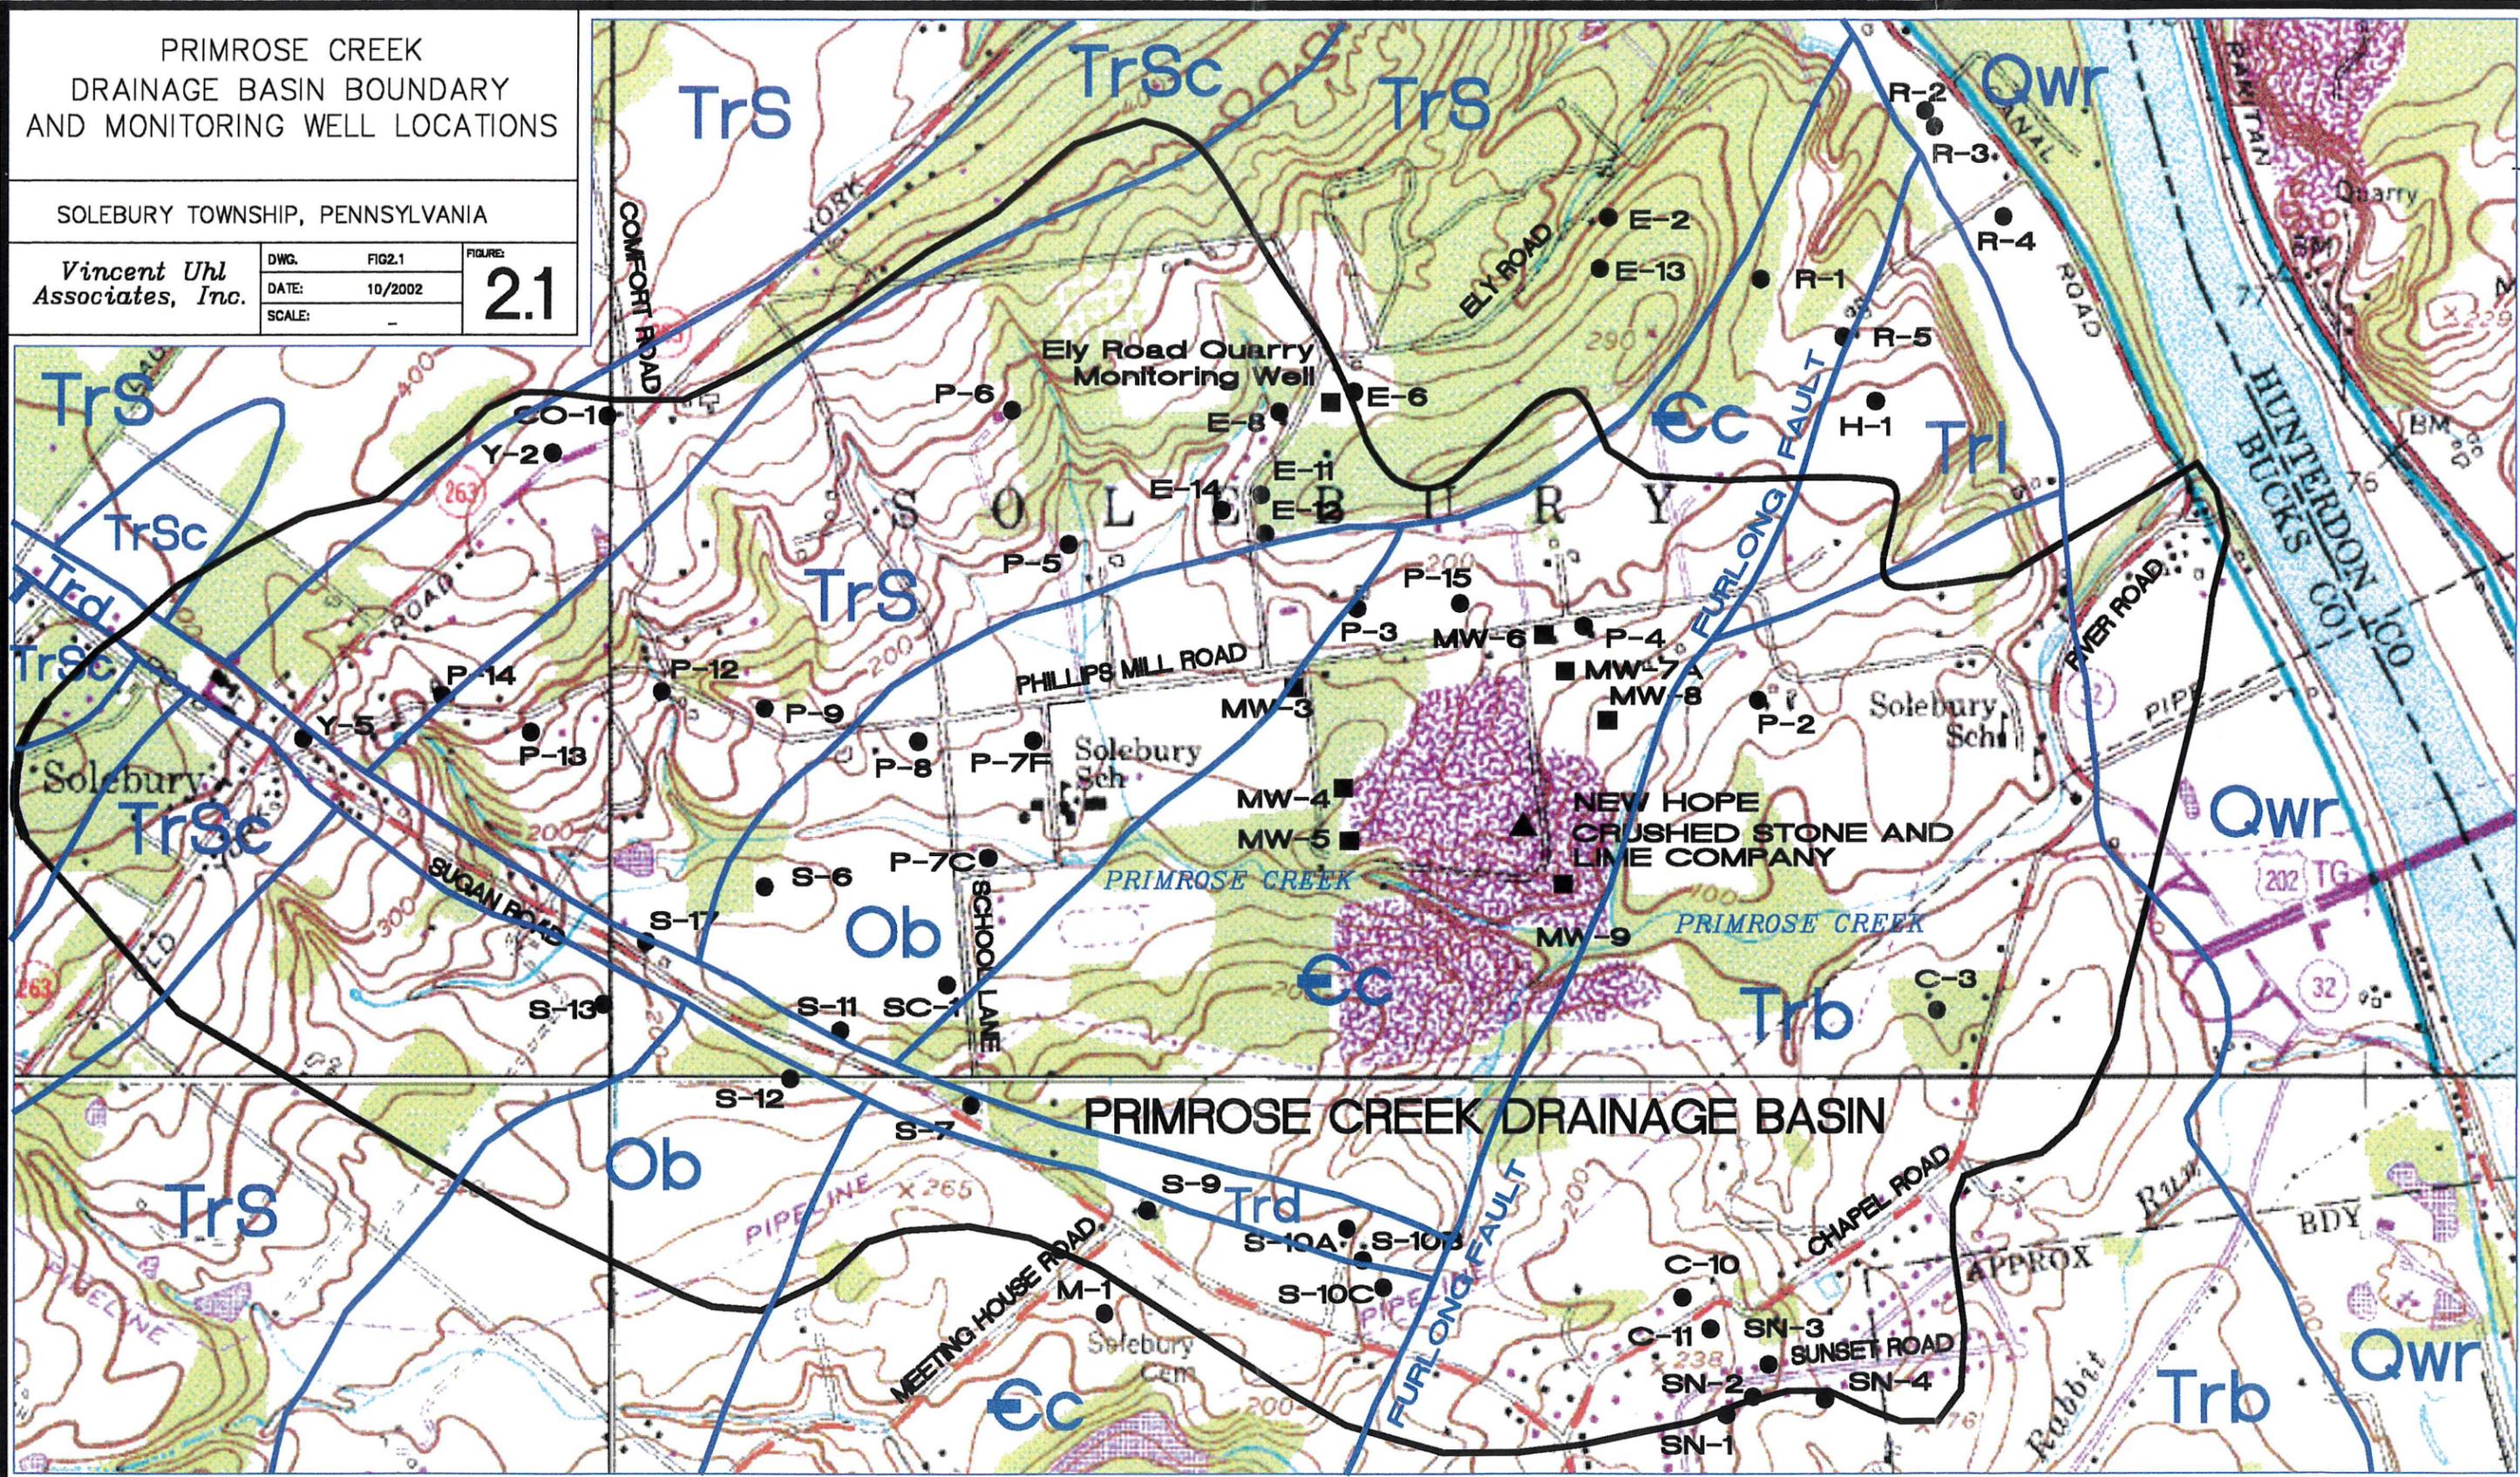
DWG.	FIG. 2.1	FIGURE:
DATE:	10/2002	2.1
SCALE:	-

PRIMROSE CREEK
DRAINAGE BASIN BOUNDARY
AND MONITORING WELL LOCATIONS

P-4 ● Monitoring Network Well
MW-7A ■ Quarry Monitoring Well

Qwr = Pleistocene Wisconsin and Recent deposits
Trd = Triassic Diabase
Trb = Triassic Brunswick Formation
Ob = Ordovician Beekmantown Formation
Trl = Triassic Lockatong Formation
TrS/TrSc = Triassic Stockton Formation

Wells S-11 and S-12, completed in the carbonate rock aquifer on opposite sides of the diabase dyke (**Figure 2.1**), had very similar water elevations of 14.52 and 16.25 feet above mean sea level. The dyke has been considered by PADEP, ERG, and VUA to be a barrier boundary wherein wells completed to the southwest of the dyke were considered out of the quarry pumping influence. These new water level data indicate that this is not the case and that the diabase dyke does not act as a barrier or no flow boundary.

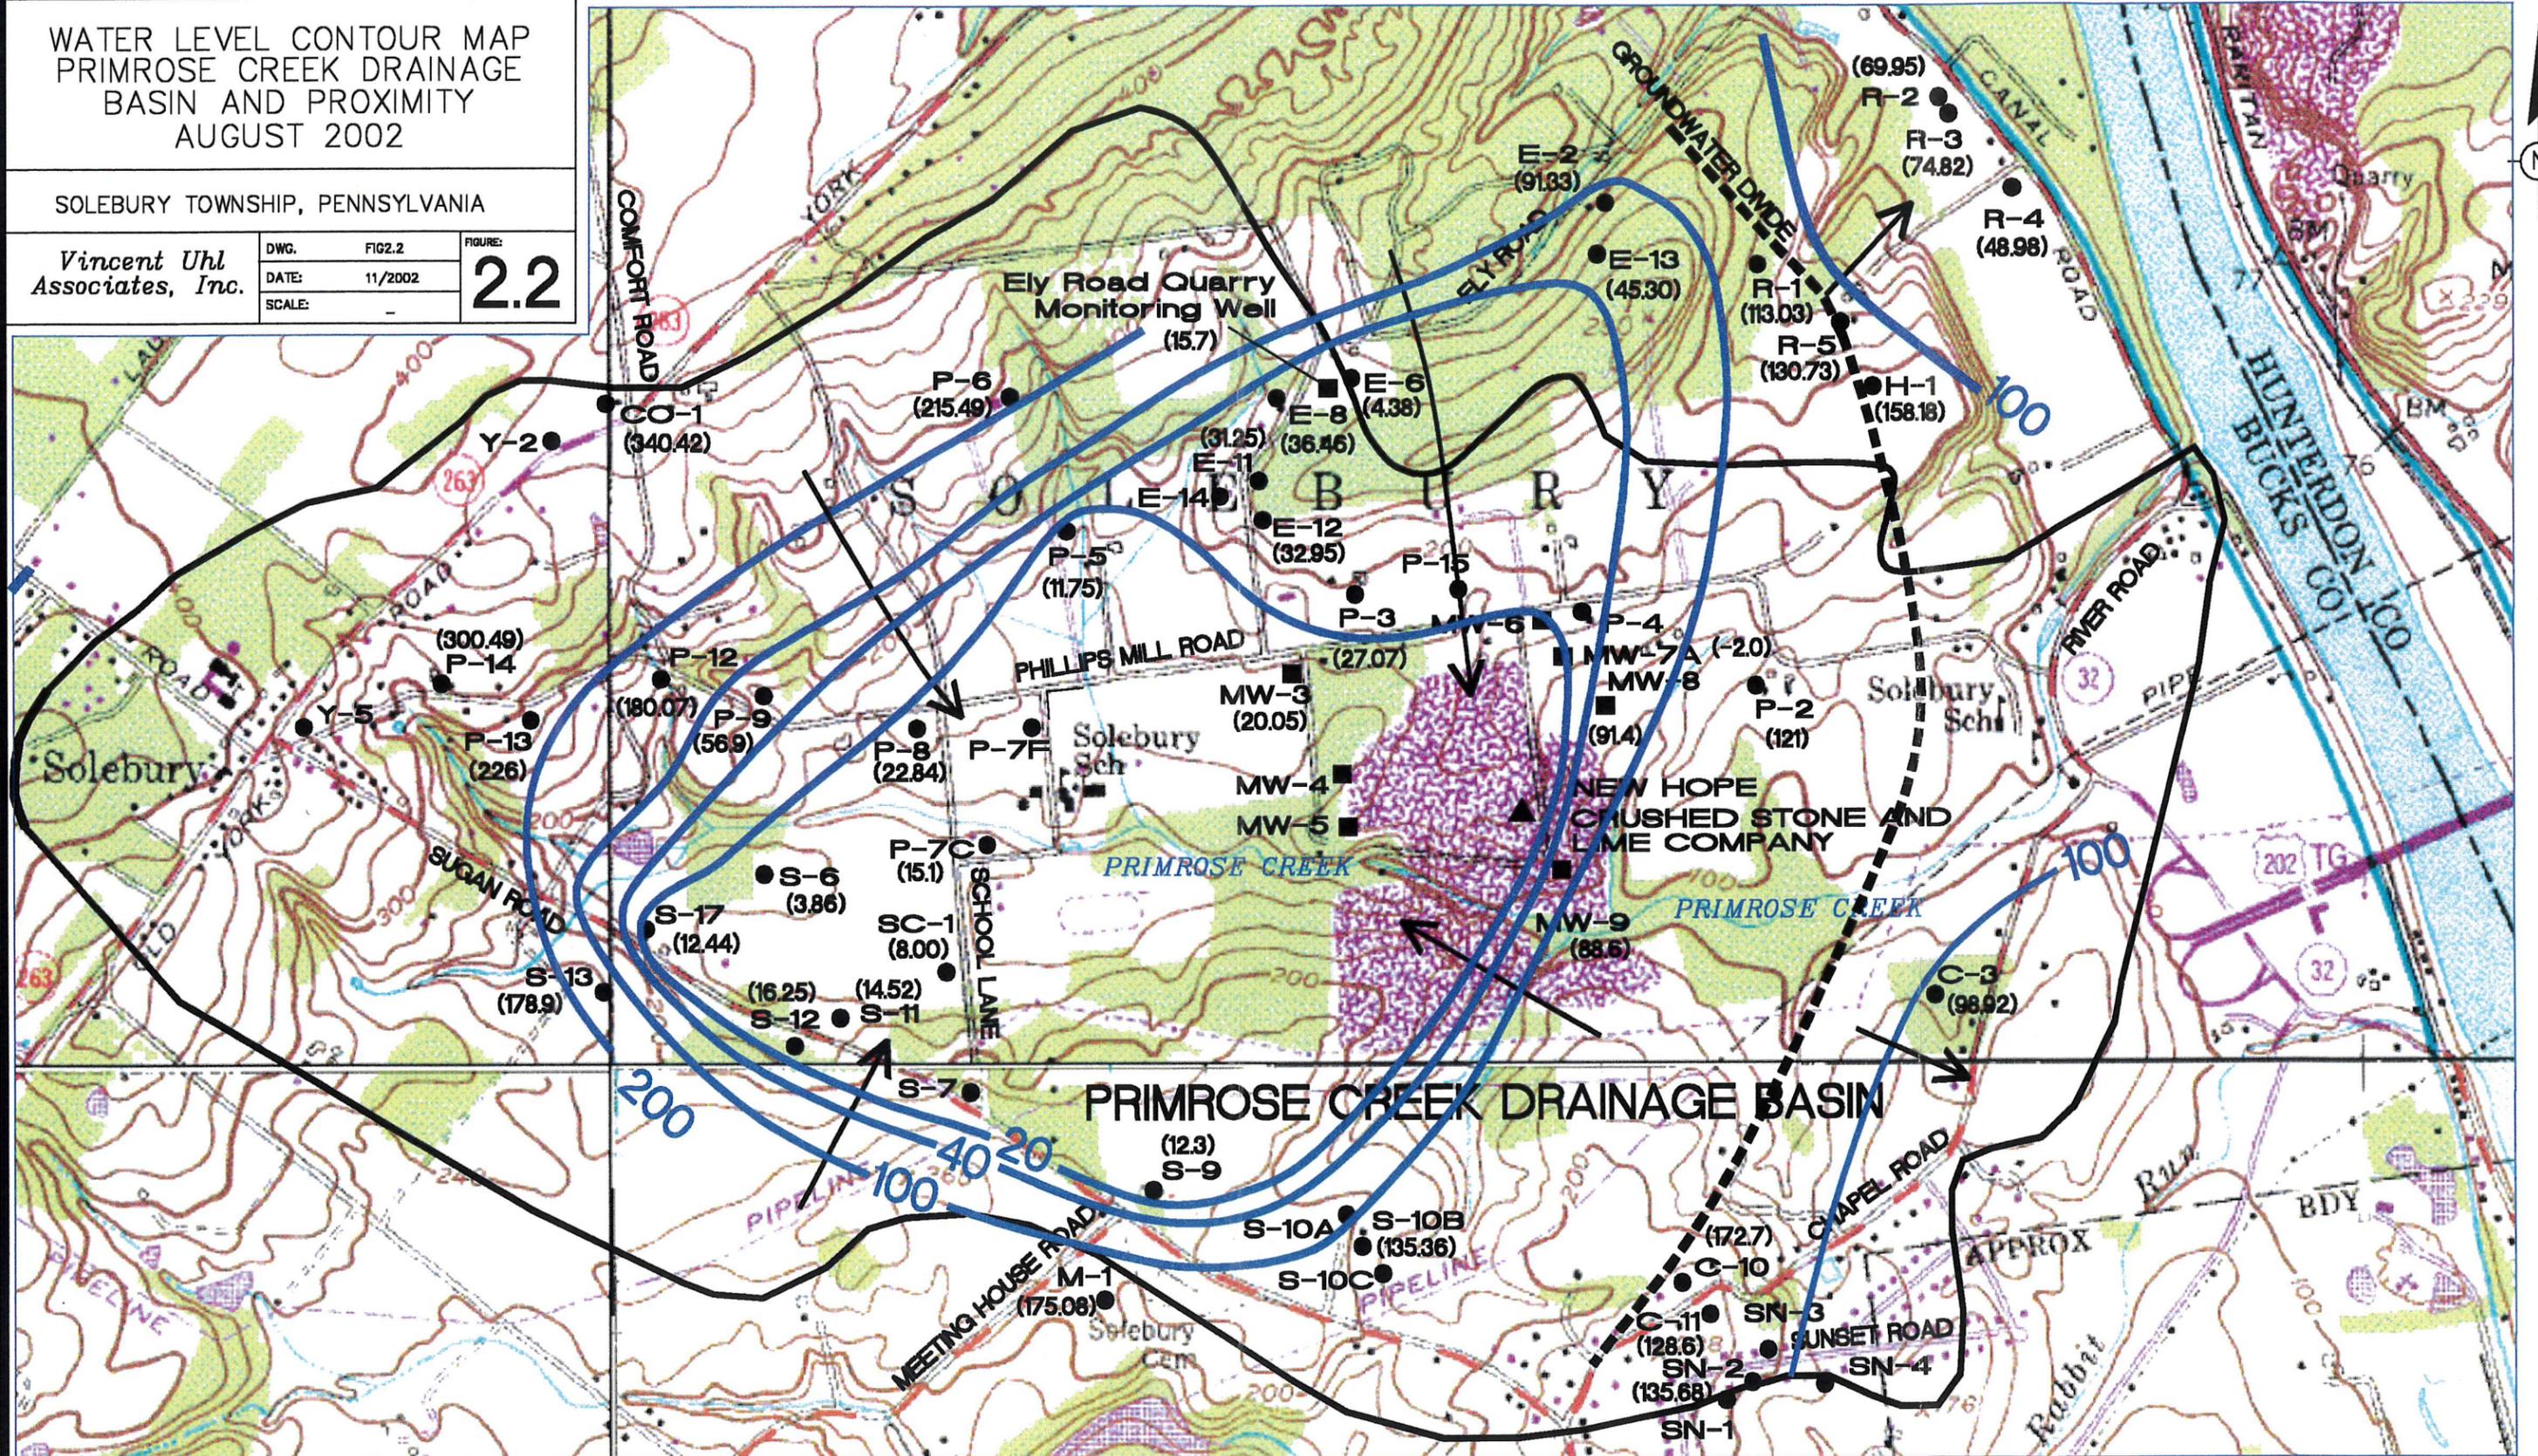
DWG.	FIG2.2	FIGURE:
DATE:	11/2002	2.2
SCALE:	-

WATER LEVEL CONTOUR MAP
 PRIMROSE CREEK DRAINAGE
 BASIN AND PROXIMITY
 AUGUST 2002

- 20 Groundwater Elevation Contour
- (215.49) Groundwater Elevation Above Mean Sea Level (AMSL)
- Direction of Groundwater Flow

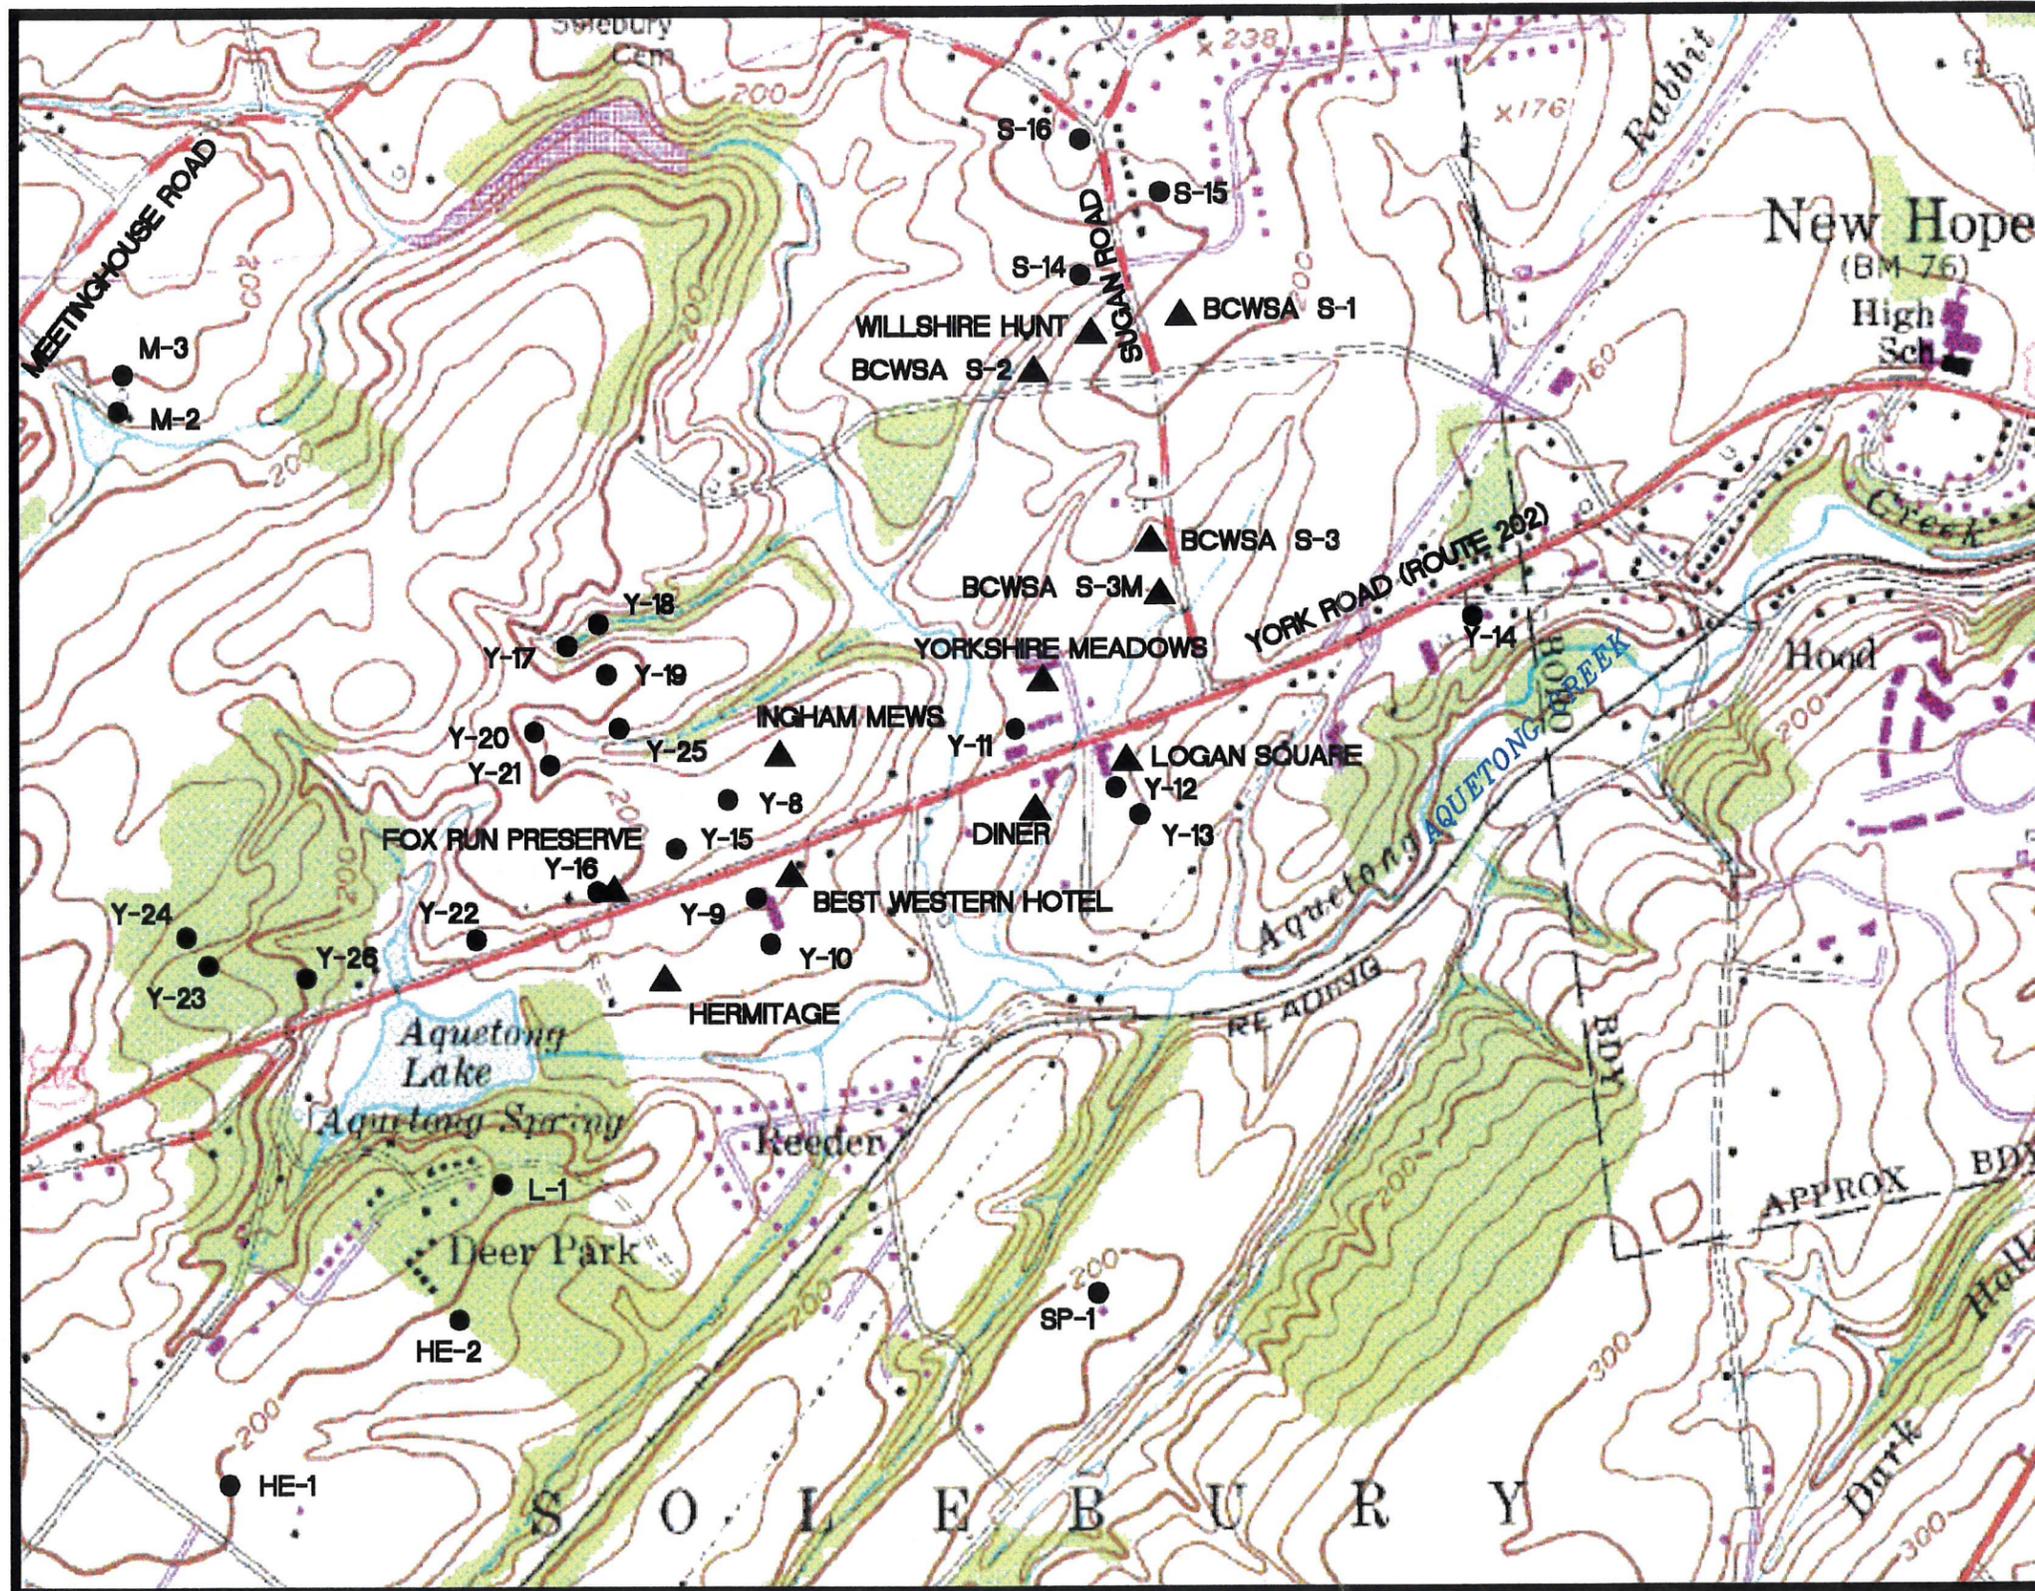
<i>Vincent Uhl Associates, Inc.</i>	DWG. SB2-2	FIGURE:
	DATE: 10/2002	2.3
	SCALE: -

- Y-8 ● WATER LEVEL MEASURING POINT
- ▲ MAJOR PUMPING CENTER

LOCATION OF WATER LEVEL MONITORING WELLS
AND MAJOR PUMPING CENTERS

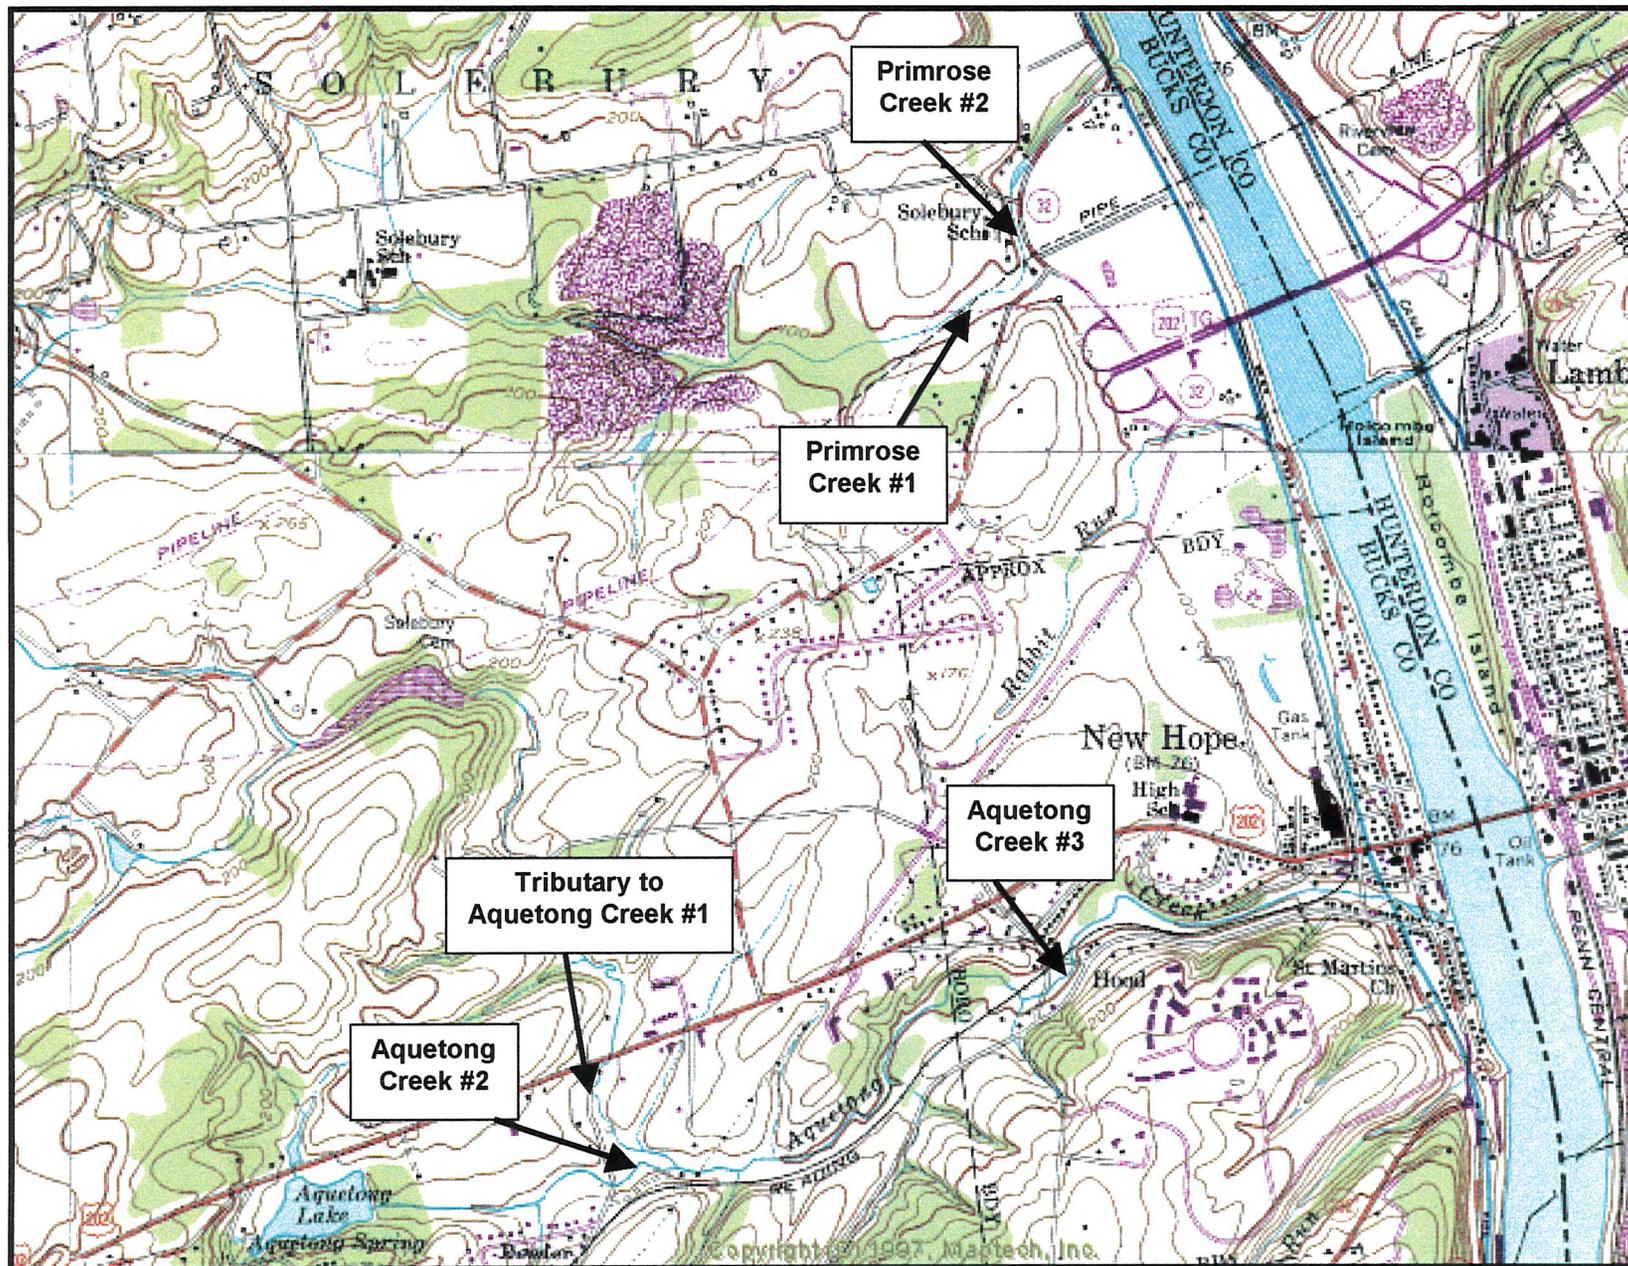
Figure 3.1. Stream Flow Measurement Locations

Stream flow was measured at two locations along Primrose Creek downstream of the quarry (**Figure 3.1**). The measurements were made on September 24, 2002, during a dry base-flow period. The upstream location (Primrose Creek No. 1) had a flow of 1,222 gallons per minute (gpm) (**Table 3.1**). Approximately 1,200 feet downstream (Primrose Creek No. 2), stream flow was measured at 1,141 gpm. The stream flow rate measurements for Primrose Creek are greater than the previous measurements in March 2002 and slightly lower than the September 2001 measurements.

Stream flow measurements were made at two locations along Aquetong Creek and at one major tributary proximate to its confluence with Aquetong Creek (**Figure 3.1**) on September 24, 2002 during a dry base-flow period. Stream flow downstream of Aquetong Lake (Aquetong No. 2) was measured at 1,708 gpm (**Table 3.1**). Within the tributary to Aquetong Creek (Tributary to Aquetong Creek No. 1), stream flow was measured at 142 gpm. Approximately 5,000 feet downstream of the confluence with the tributary, stream flow in Aquetong Creek (Aquetong Creek No. 3) was measured at 2,147 gpm. These flow rate measurements are lower than the March 2002 measurements with the exception of the measurement at the confluence (No. 3). These measurements are greater than the September/November 2001 measurements with the exception of the tributary (No. 1) which was lower.

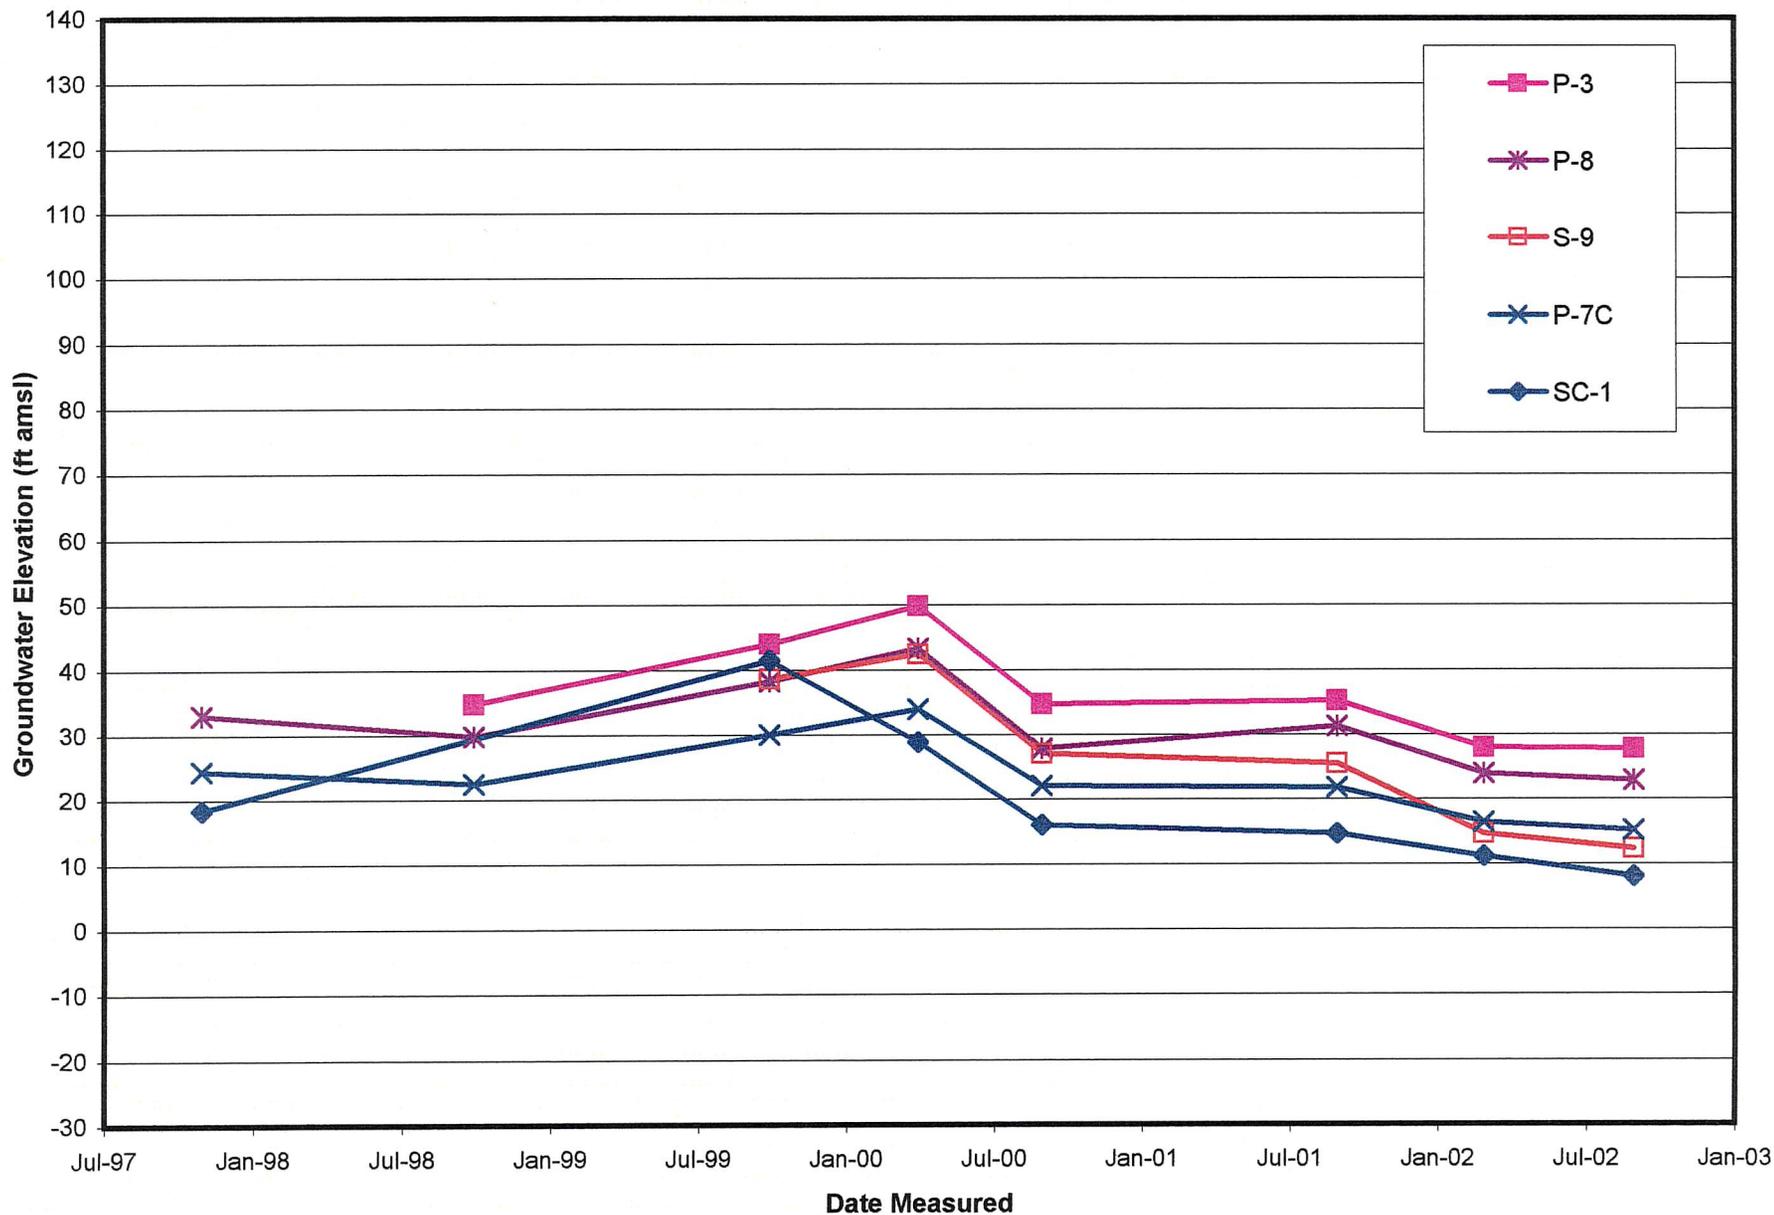
**Figure A.1. Primrose Creek Drainage Basin:
Wells in Carbonate Rock Aquifer Influenced by Quarry
(Phillips Mill Road, Sugan Road, and School Lane)**

Figure A-1 provides water-level hydrographs for 5 wells completed in the carbonate rock aquifer and under the influence of the quarry pumpage. Water levels in these five wells have shown modest declines since the initiation of monitoring in 1997. In this same timeframe Quarry pumpage has decreased from a high of 2.55 MGD in 1997.

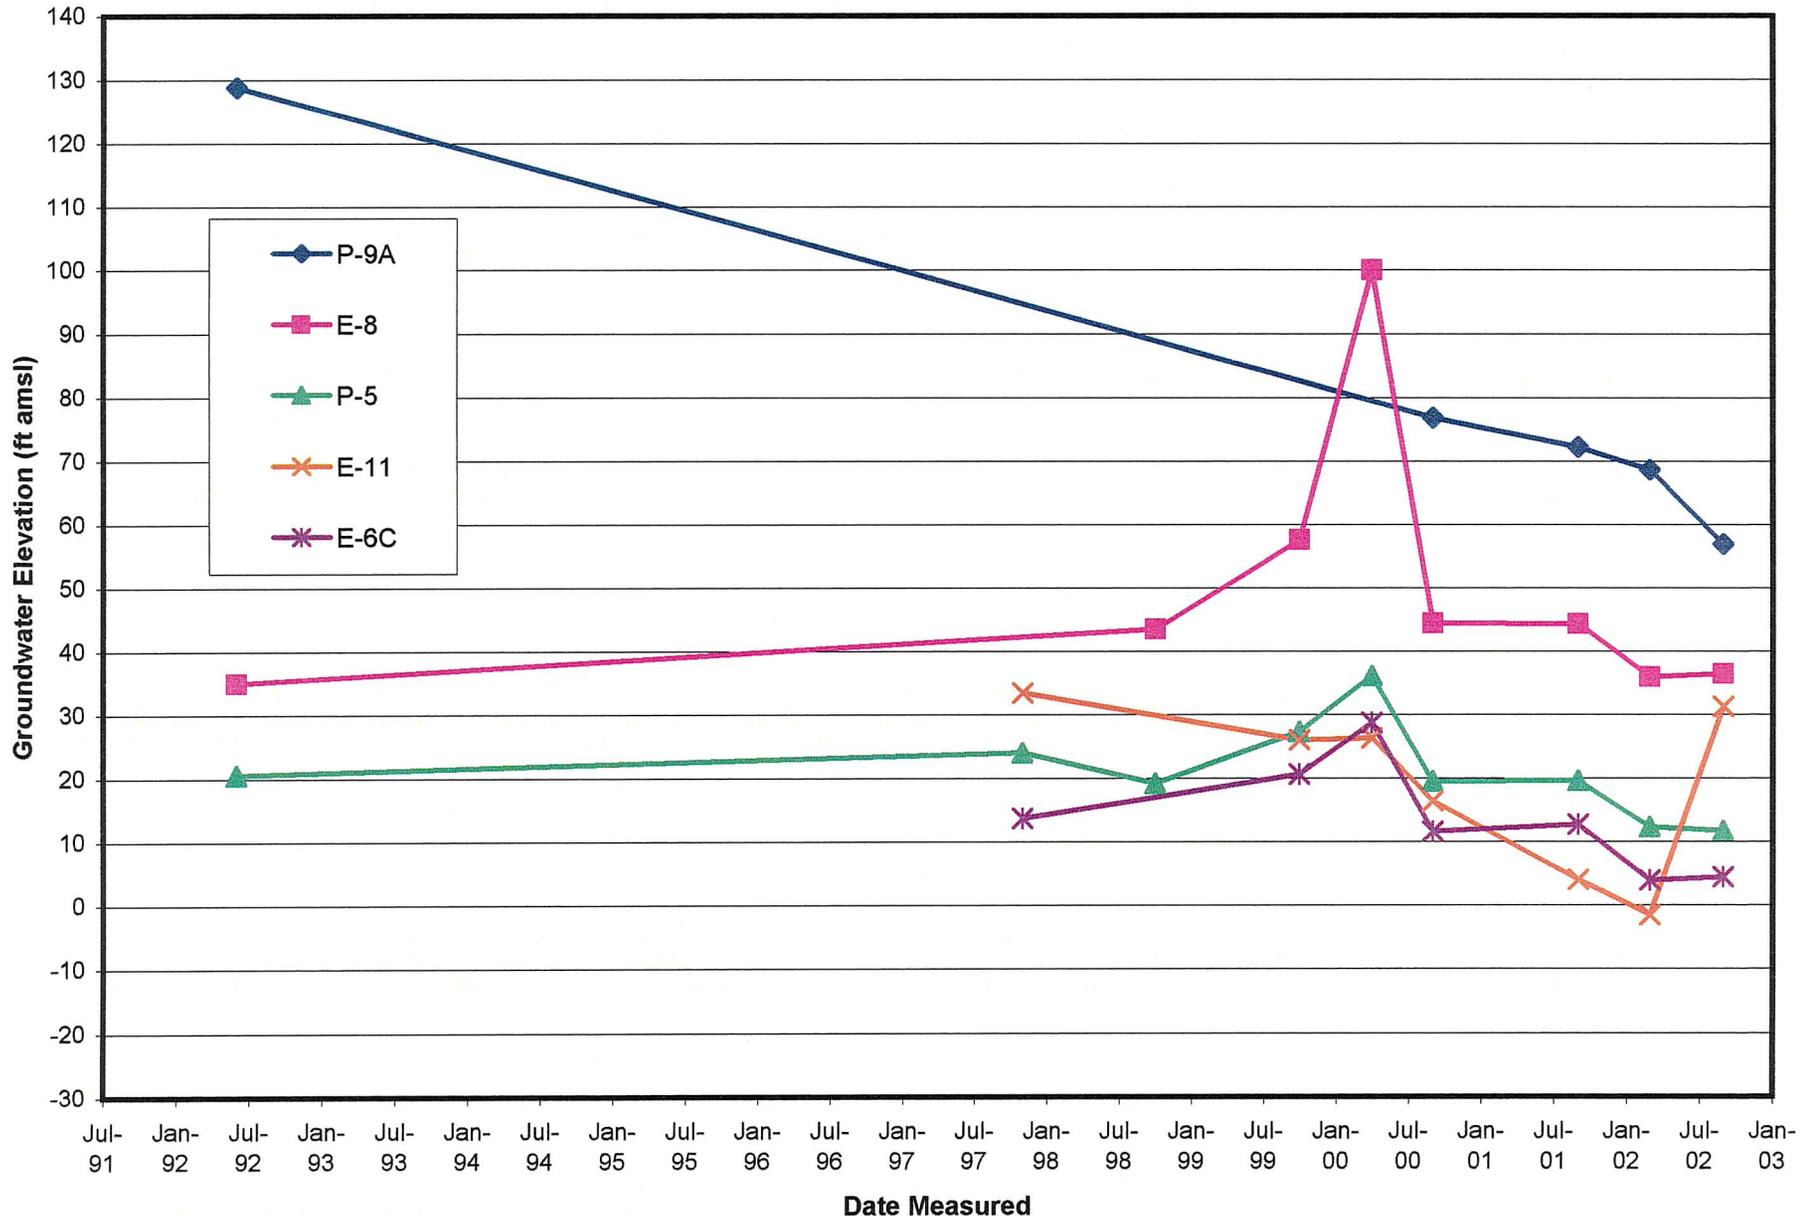
Figure A.2. Primrose Creek Drainage Basin: Wells in Stockton Sandstone Within 1,000 Feet of Carbonate Rock Contact (Phillips Mill Road and Ely Road)

Figure A-2 characterizes water level conditions for wells completed in the Stockton Sandstone within 1,000 feet of the carbonate rock aquifer contact. Certain of these wells may be completed in both the Stockton and underlying carbonate rock aquifers. Water levels in the five wells located on Ely Road and Phillips Mill Road have all shown declines from the earliest records in 1992 to August 2002 except for E-11. Overall the declines have been from as much as 70 feet (P-9A) to 10 feet (P-5 and E-6C)

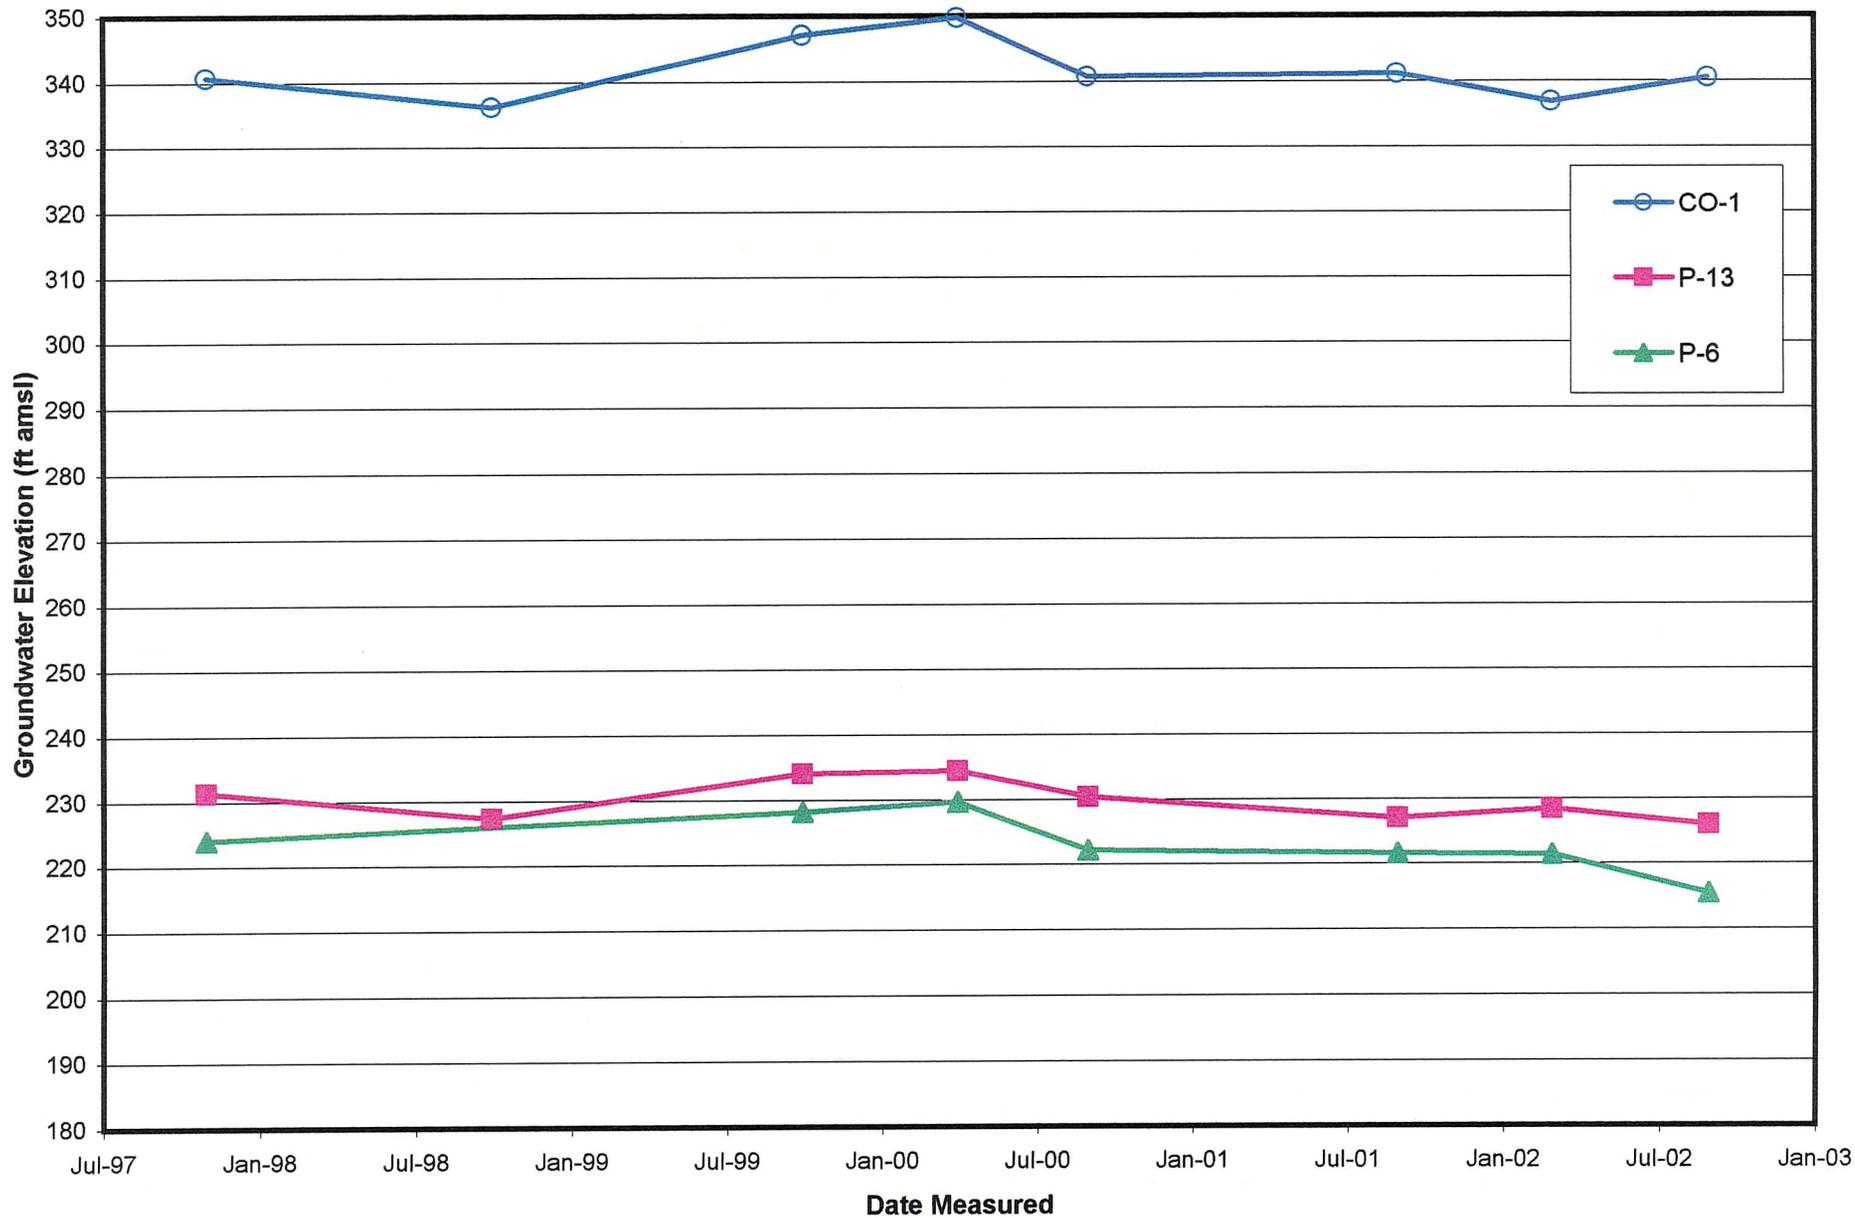
Figure A.3. Primrose Creek Drainage Basin: Wells in Stockton Sandstone Greater than 1,000 Feet from the Carbonate Rock Contact (Comfort Road and Phillips Mill Road)

Figure A-3 is characteristic of water levels for wells completed in the Stockton Sandstone that appear un-influenced by the Quarry pumpage at current rates of withdrawal. These wells are located further to the west and north of the Quarry (and Carbonate Rock Aquifer contact) as compared to the wells shown on **Figure A-2**. Of interest is that water level fluctuations in these three plotted wells (CO-1, P-6, and P-13) are on the order of a few feet as compared to water level changes in wells under the influence of Quarry pumping which show a much wider range of fluctuation.

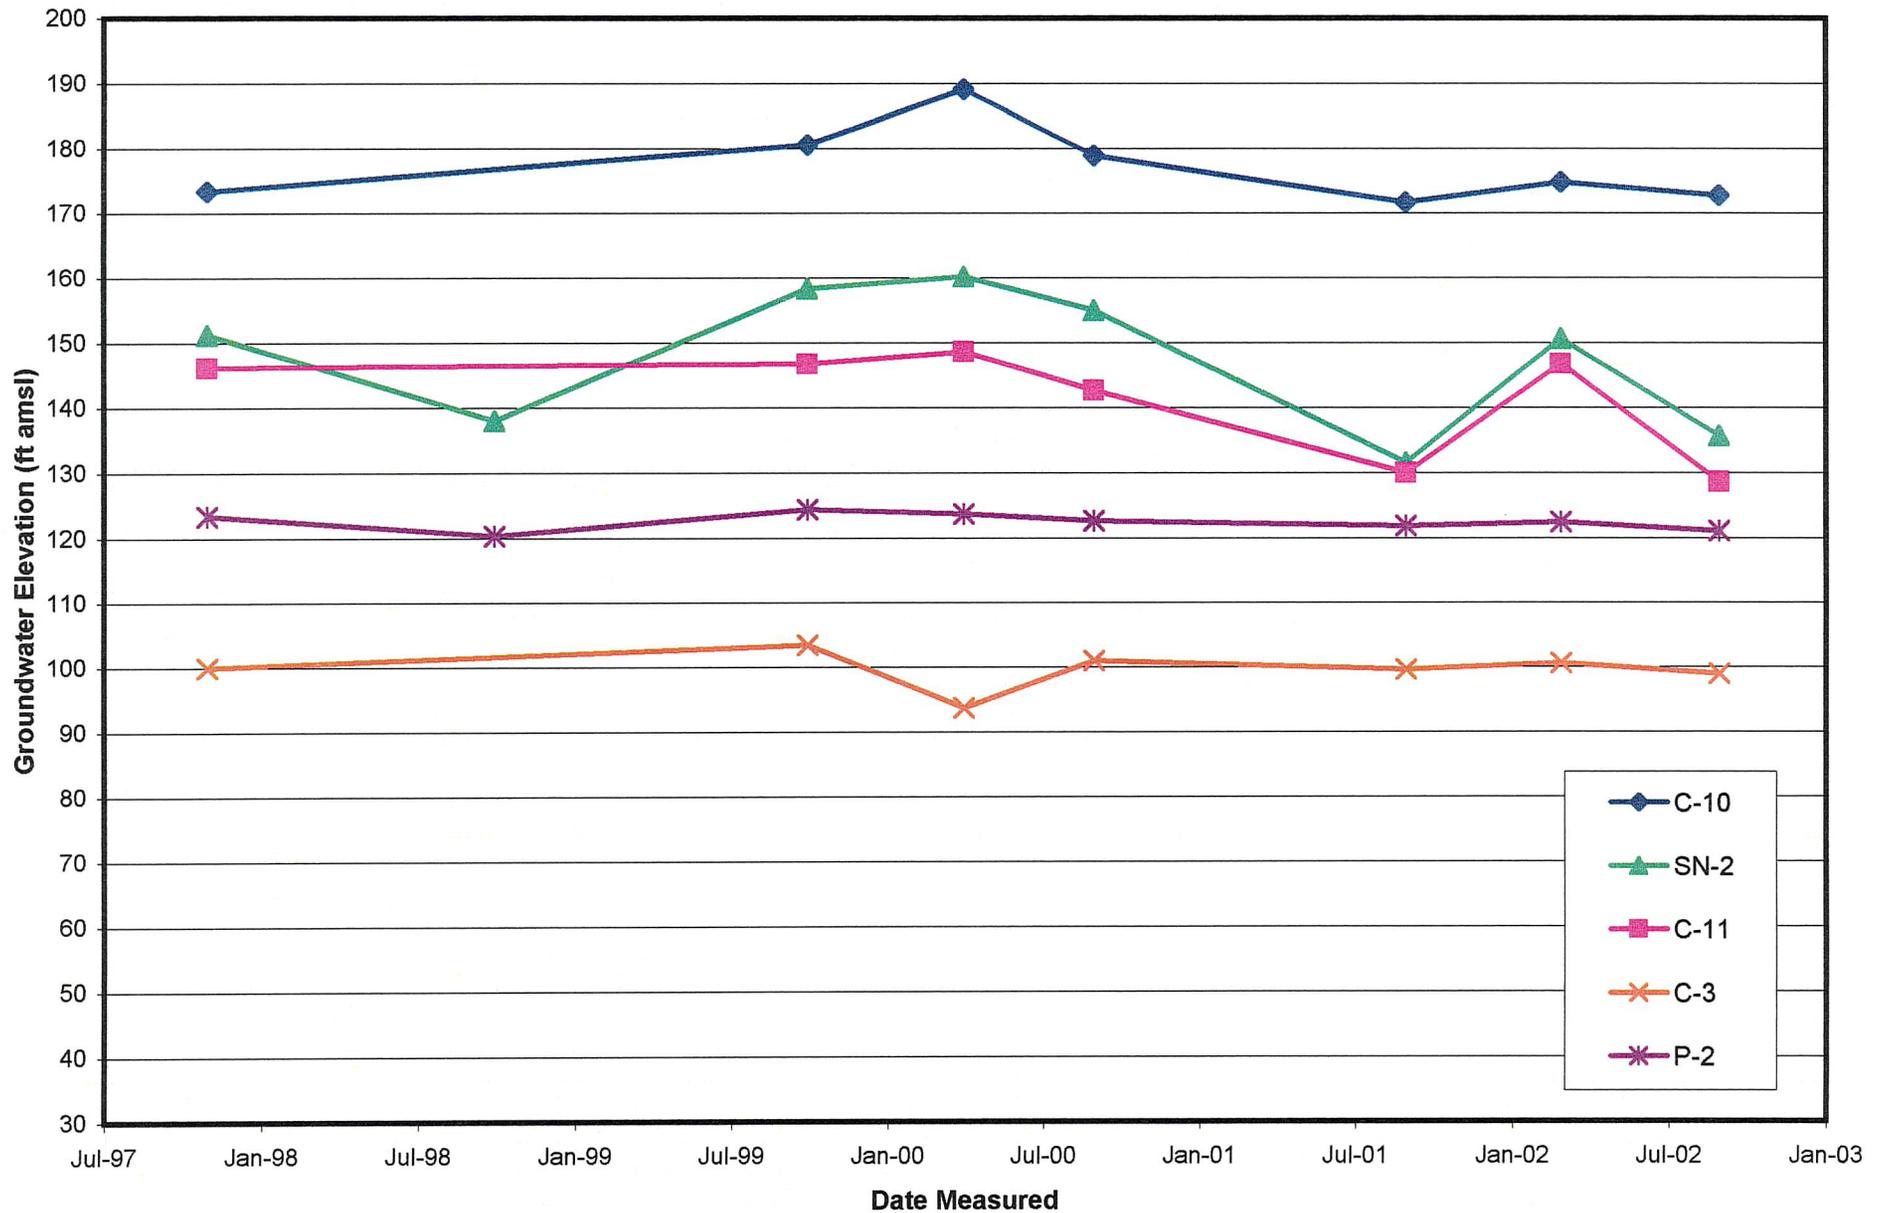
**Figure A.4. Primrose Creek Drainage Basin:
Wells in Brunswick Shale
(Phillips Mill Road, Chapel Road, and Sunset Drive)**

Figure A-4 is characteristic of water levels in the Brunswick shale along Phillips Mill Road, Chapel Road, and Sunset Drive. Well P-2 lies very close to the Furlong Fault and the Quarry. This well has shown very little water-level fluctuation over the past 5 years as has well C-3. Wells C-10, C-11, and SN-2 are located near the drainage divide between the Primrose Creek and Aquetong Creek drainage basins. Water level fluctuations in these three wells may reflect the influence of the nearby public water supply pumpage for the existing and new developments in the Aquetong Creek drainage basin.
