**AUGUST 2002 GROUNDWATER ELEVATION AND
STREAM FLOW MONITORING
PRIMROSE AND AQUETONG CREEK DRAINAGE BASINS
SOLEBURY TOWNSHIP, PENNSYLVANIA**

**Solebury Township
3092 Sagan Road
Solebury, Pennsylvania 18963**

November 2002

**Vincent Uhl Associates, Inc.
P.O. Box 93
Washington Crossing, Pennsylvania 18977**

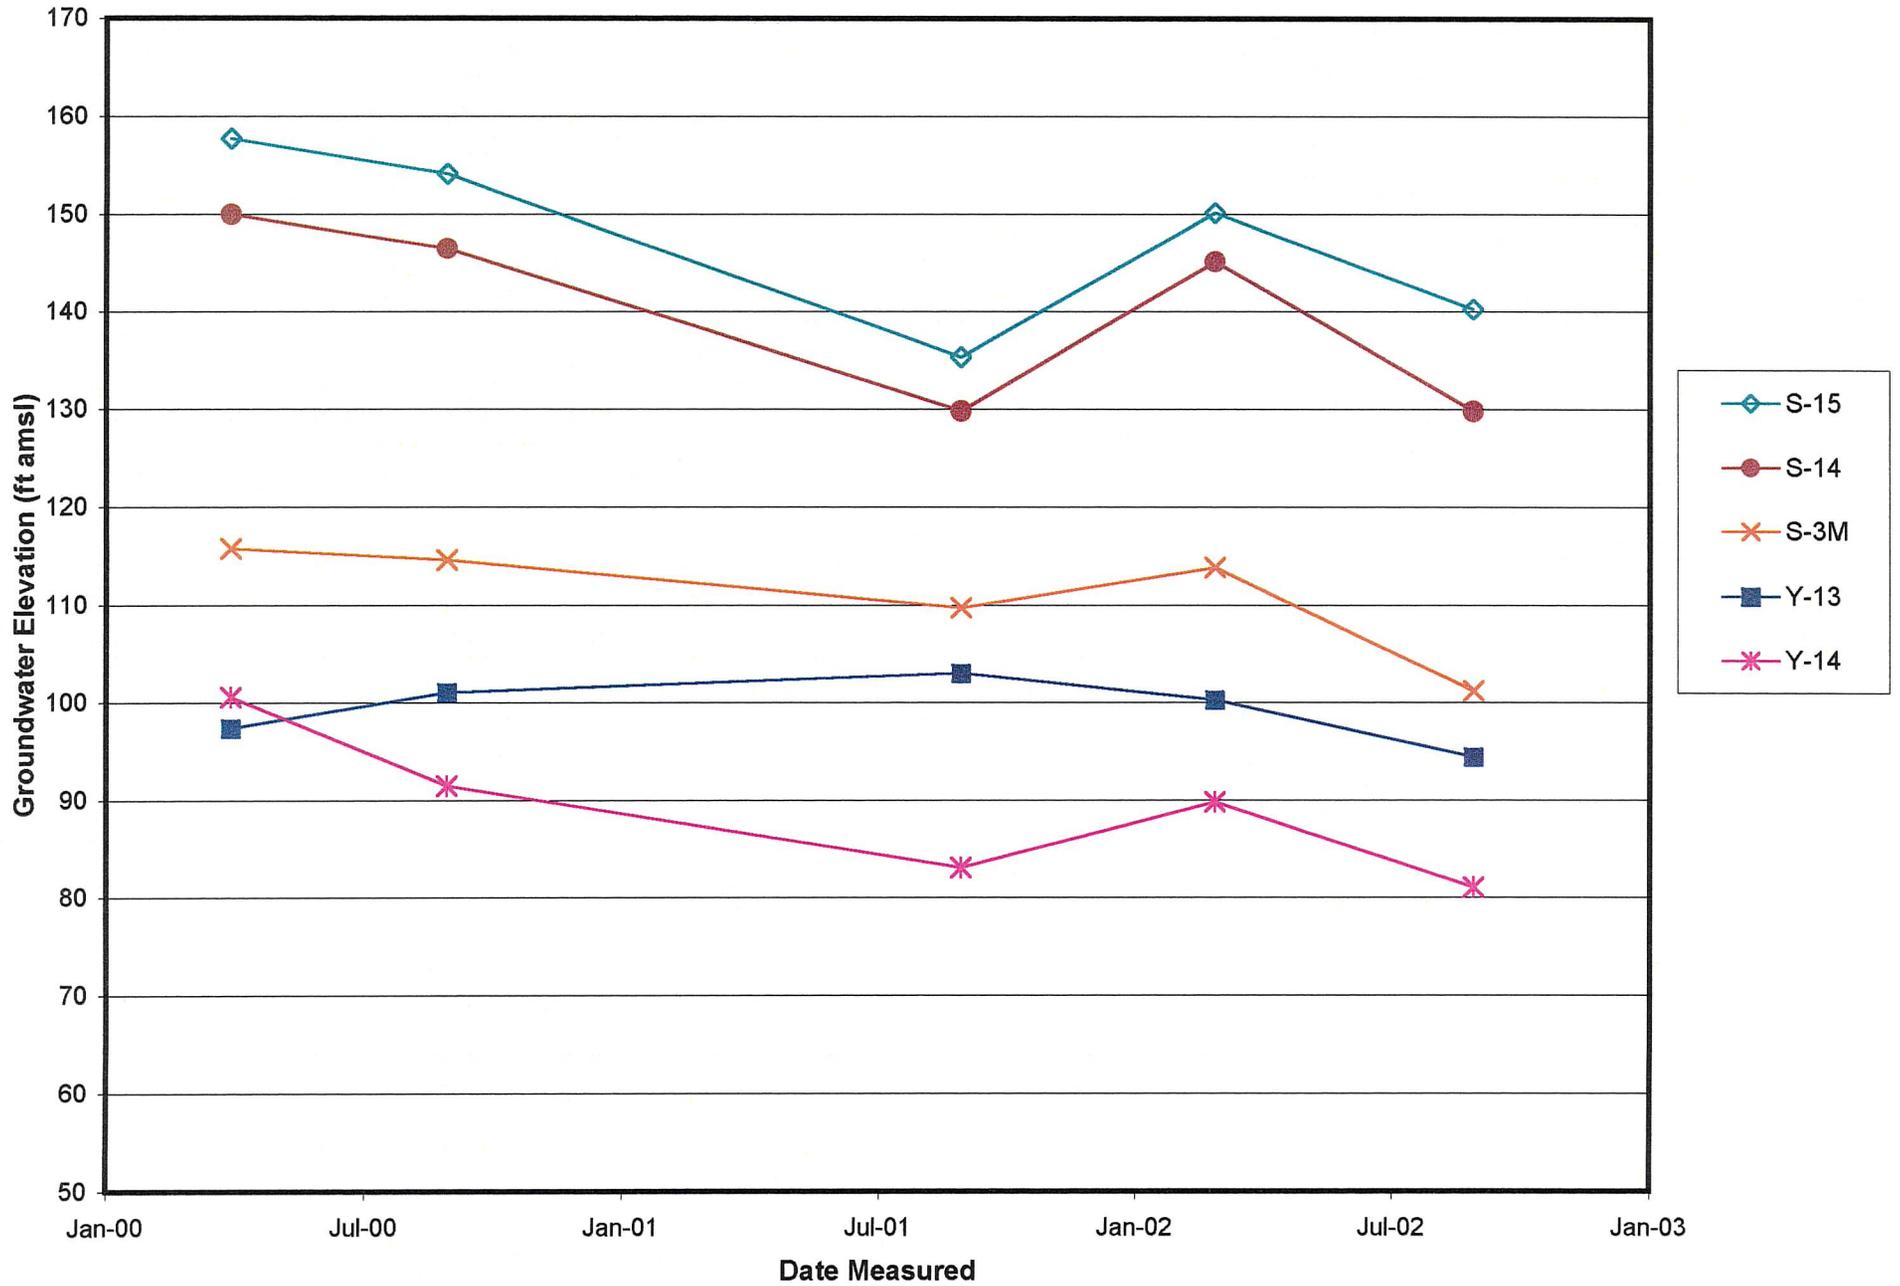
Figure A.5: Northeastern Aquetong Creek Drainage Basin

Figure A.5 is for the east-northeast part of the basin along Sugan Road and near the Sugan Road and Route 202 intersection. This is the area in the drainage basin with the most concentrated water supply pumpage for the Wilshire Hunt, Marshall Tract, Yorkshire Meadows, Logan Square, and Fieldstone communities.

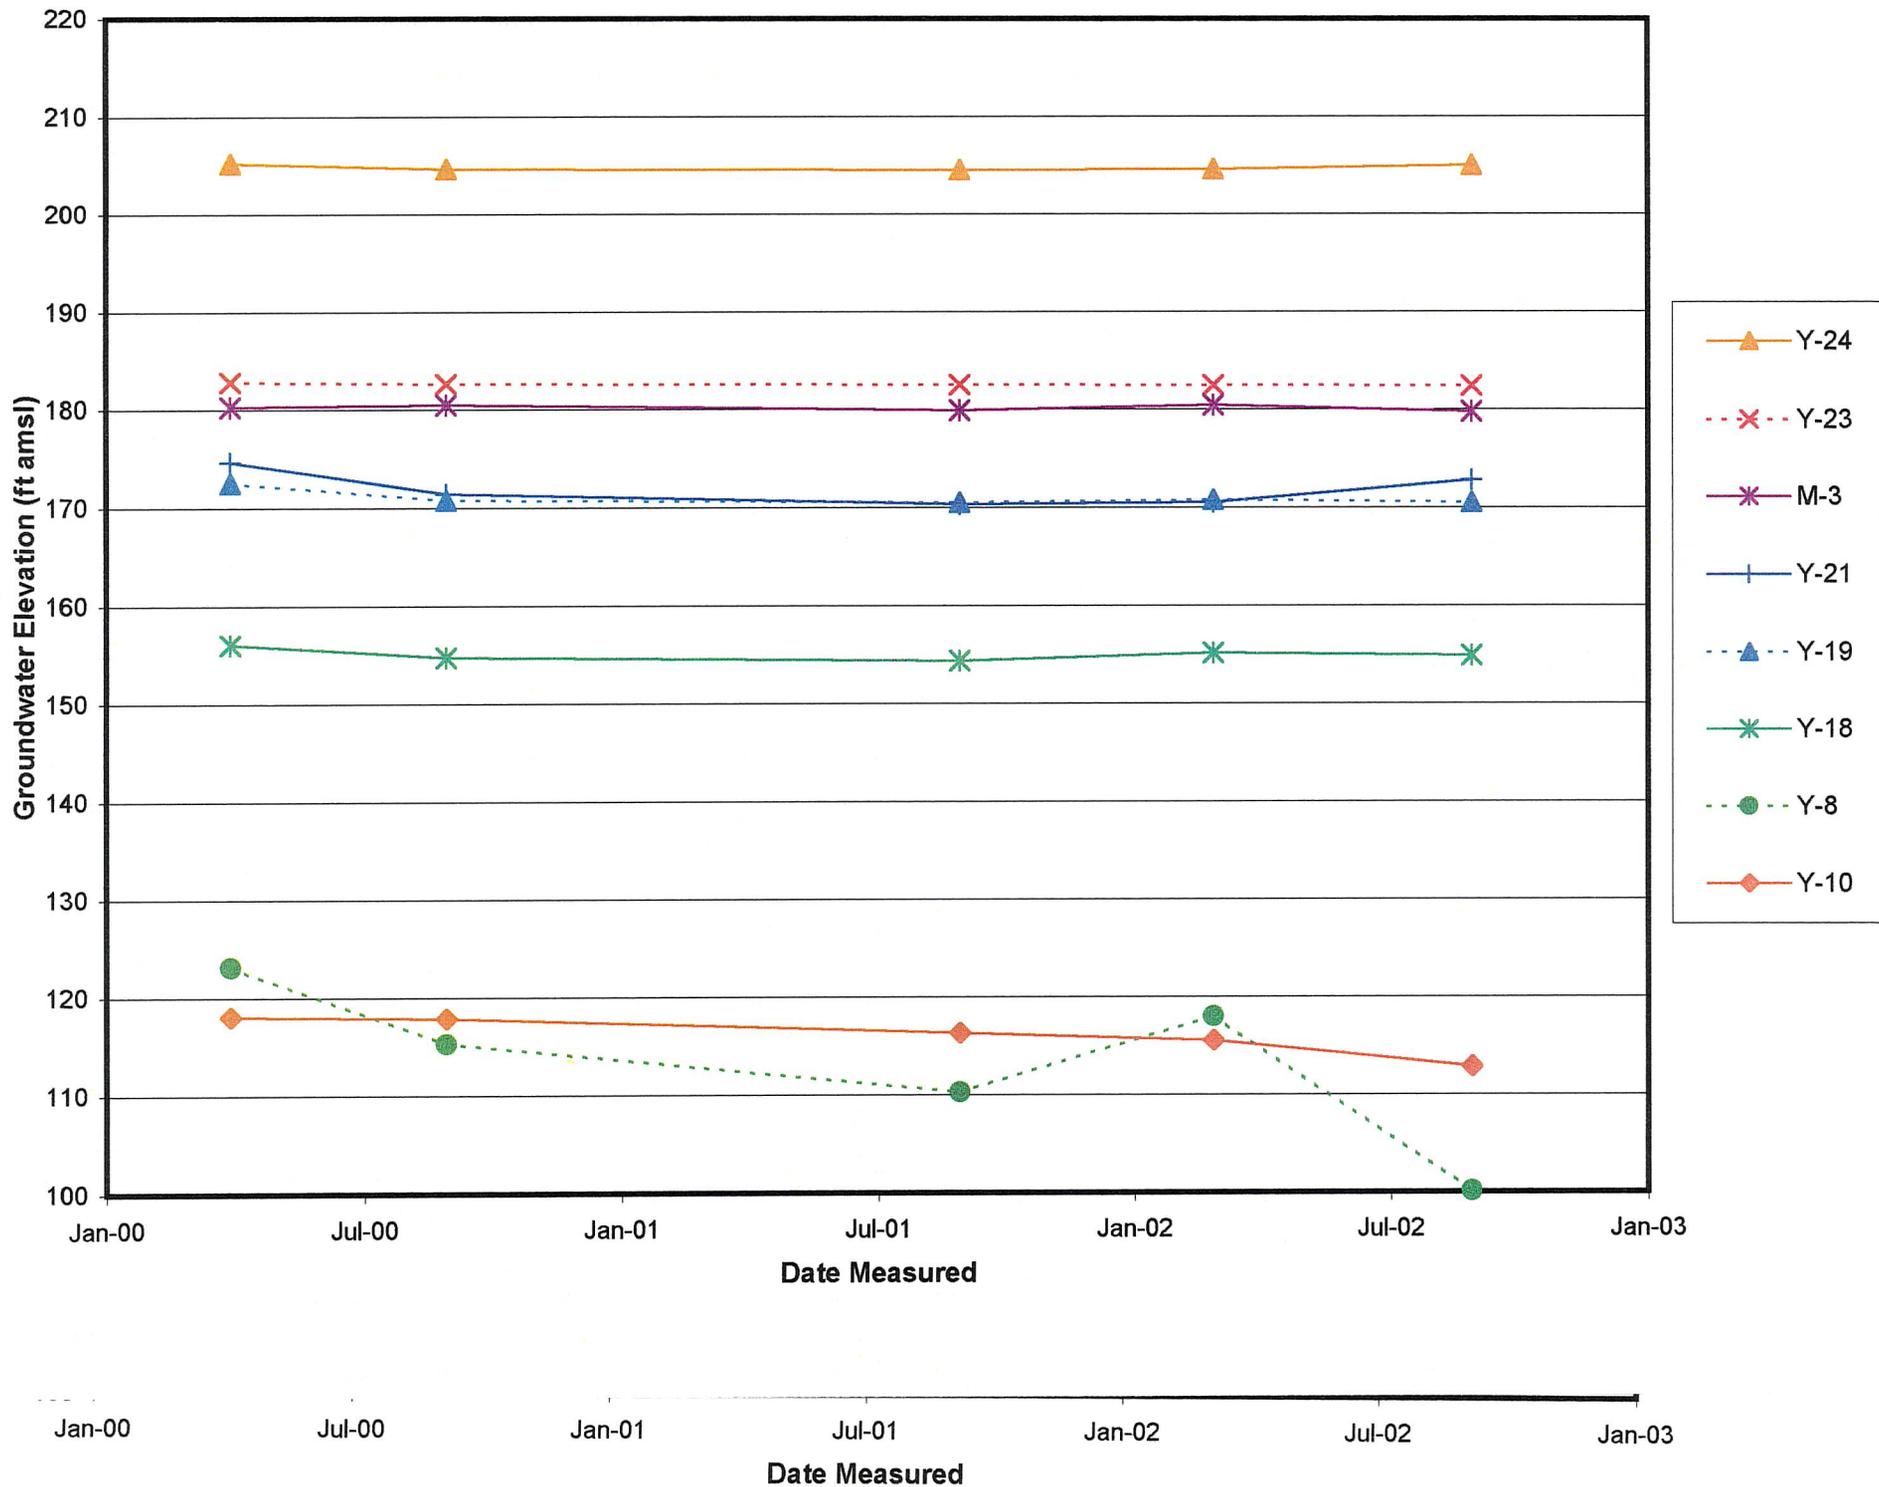
Figure A.6: Western Portion of Aquetong Creek Drainage Basin

Figure A.6 is for the western part of the drainage basin along Route 202 and north of Route 202 along Meetinghouse Road. Along Route 202, the principal pumping withdrawals are for the Fox Run Preserve, Hermitage, Ingham Mews, and Best Western Hotel.
